Crookhill Brickpit SSSI

Report on DIGS workday 21 February 2020

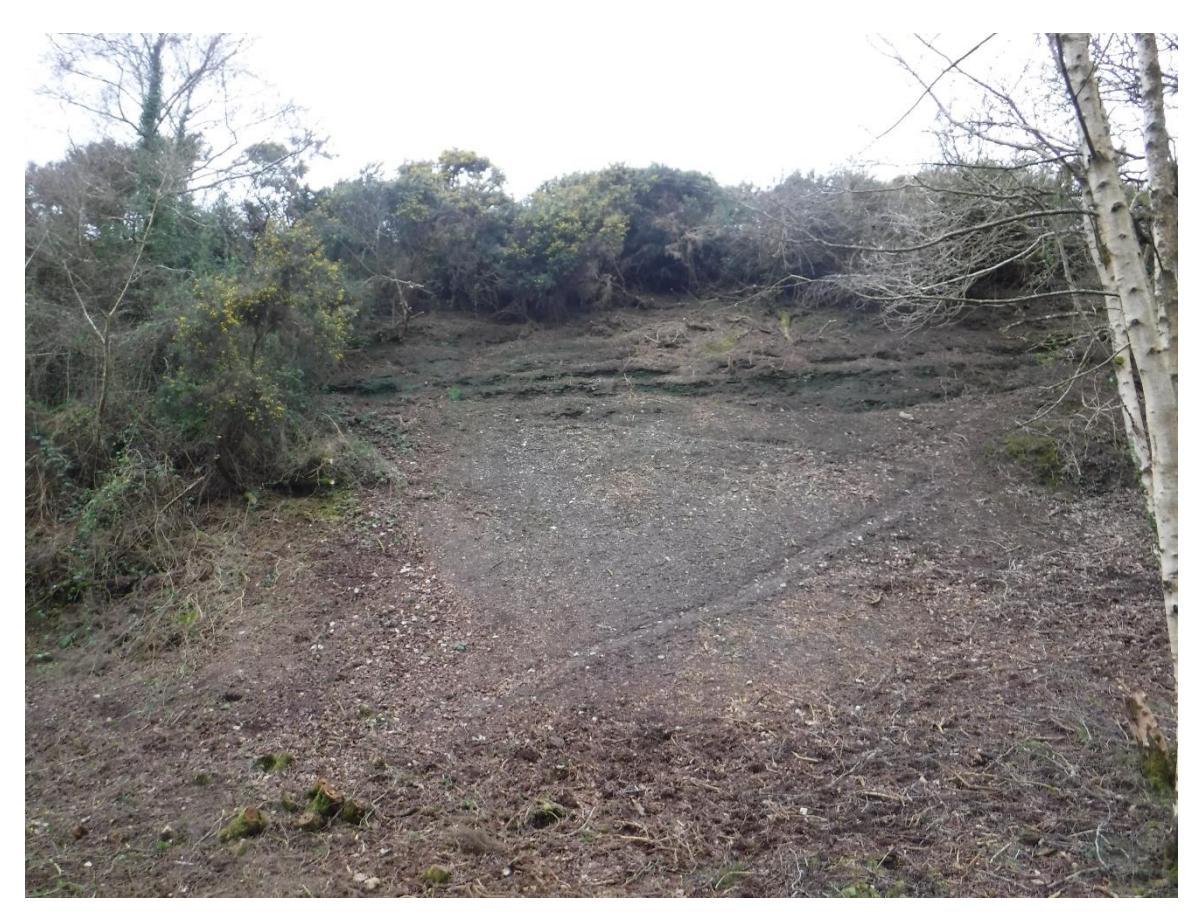
Photo 1 Completion of scrub clearance work at Location A (21 February 2020).

Despite the recent wet weather, the zigzag access path was still usable. All of this exposure is in the Peterborough Member. Shales towards the top of the exposure contain abundant fossils, including compressed ammonites and bivalves. There is a badger sett just to the right of the photo.

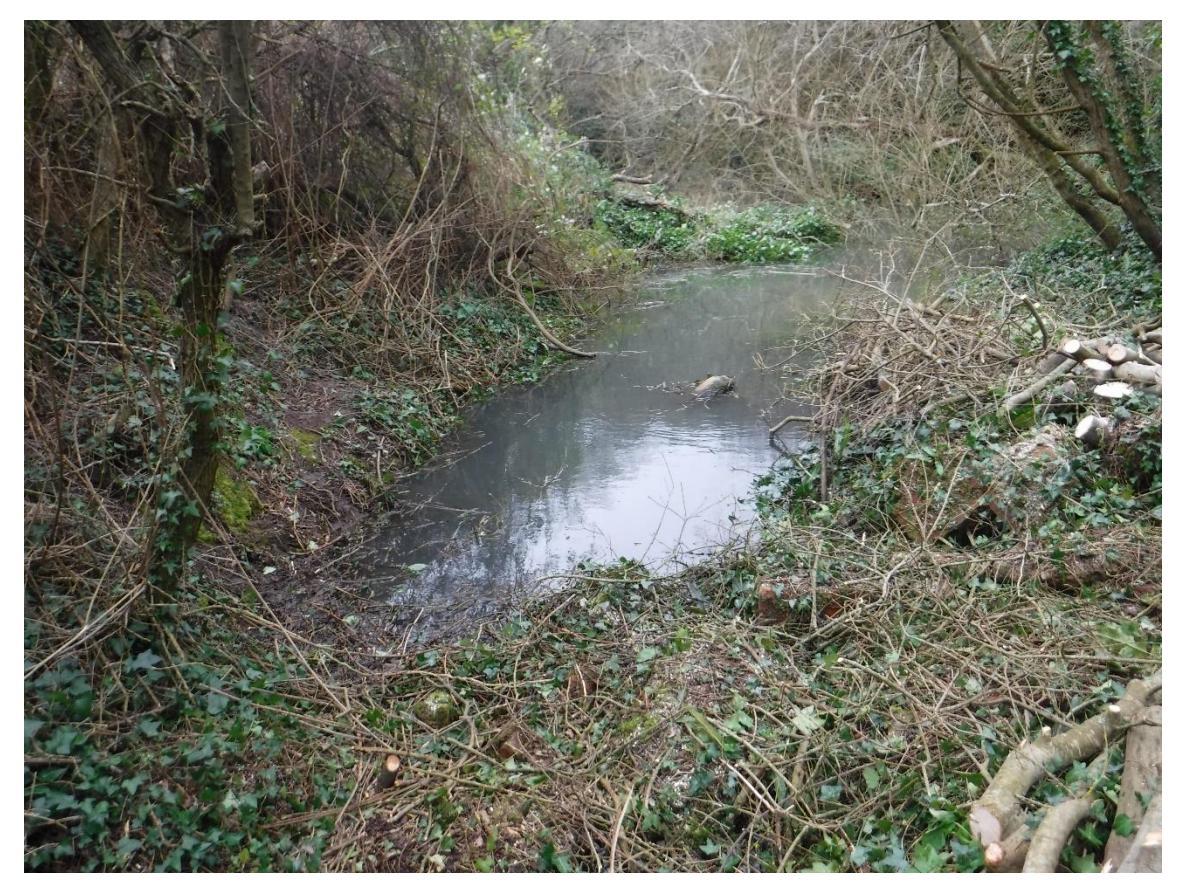
Photo 2 Habitat enhancement close to the main site access path (21 Feb 20).

Removal of small trees and creation of log piles on the bank of a seasonal extension of the main pond in order to improve the habitat for great crested newts and other species.

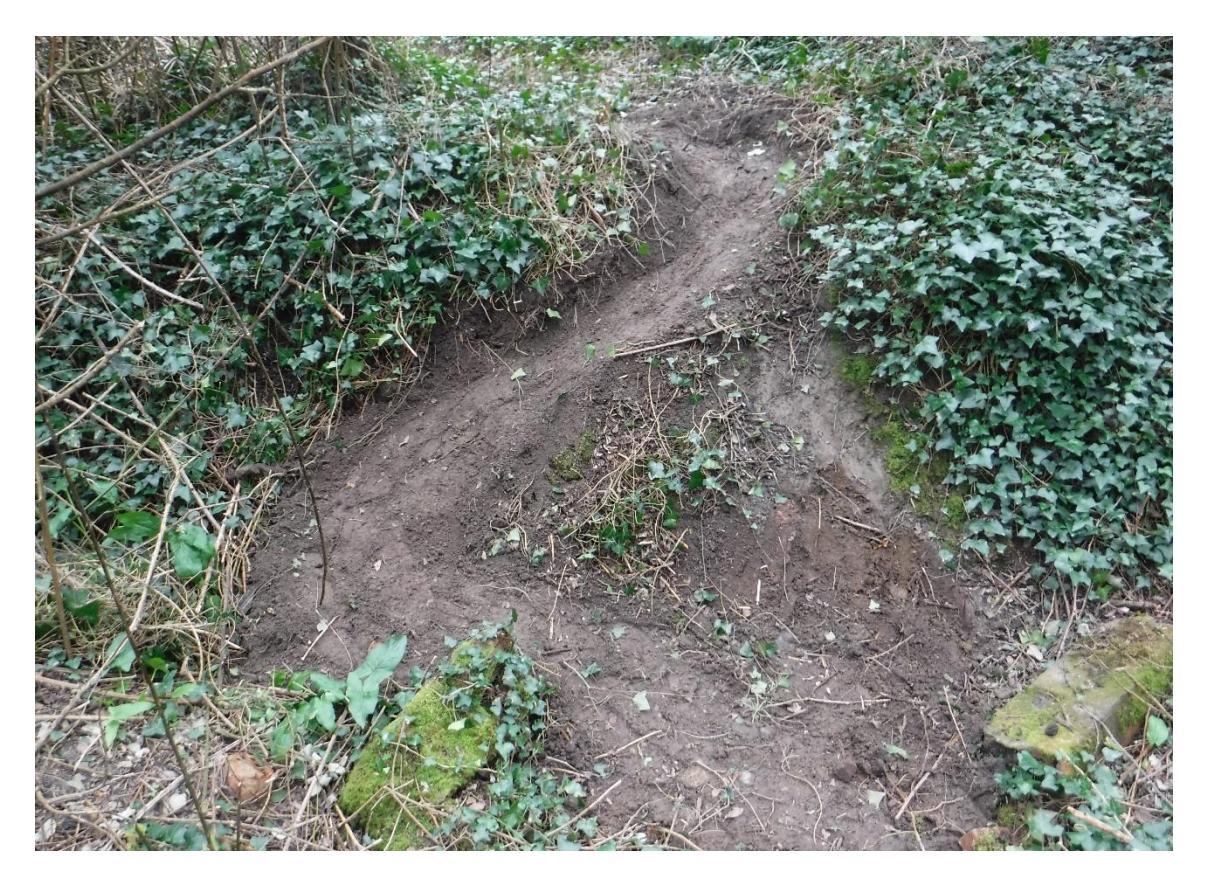
Photo 3Access path realignment around slippery slope near area shown in Photo 2 (21 Feb 20).There is a small badger sett just to the left of the path at this location.

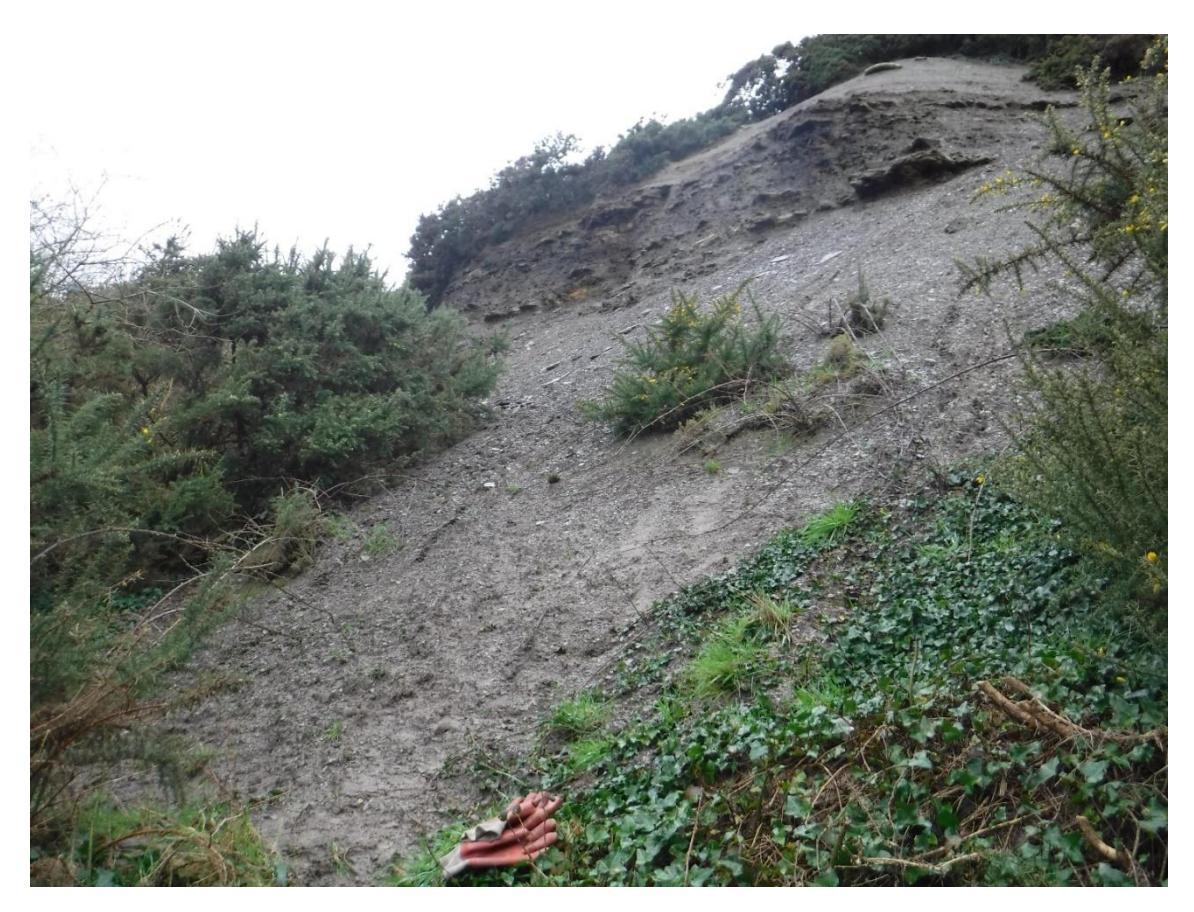
Photo 4 Location B on 19 February 2020. Stewartby Member clays overlie a prominent shale cliff in the Peterborough Member. No further scrub clearance has been carried out, but this will not impede geological investigations within the area already exposed.

Subject to permission from Natural England and Dorset Council, further geological work over the next few months might comprise careful shallow scraping at locations A, B and C. The aim would be twofold: firstly to improve access within areas which are now clear of vegetation, and secondly to reveal further parts of the succession and perhaps begin compiling a new fossil record.

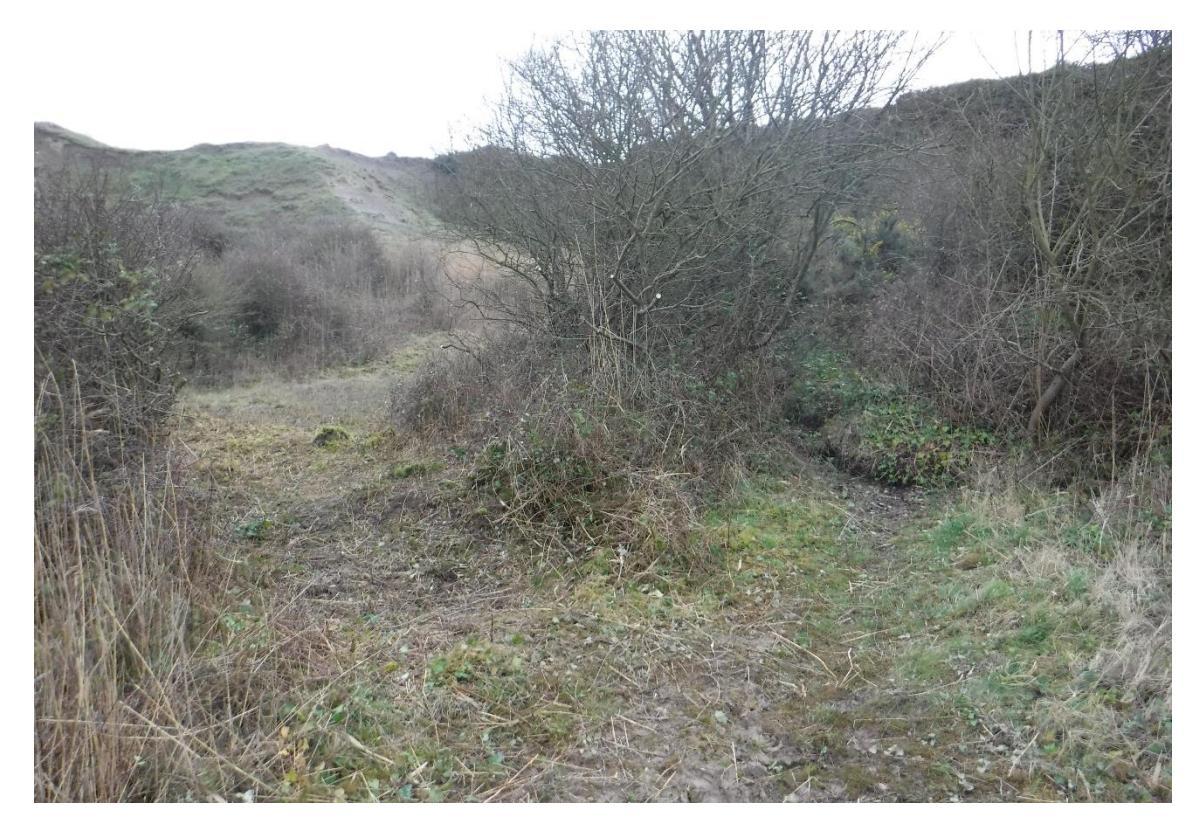
Photo 5 Access path realignment near Location C (21 Feb 20). The original path on the right was blocked by the toe of the recent landslide. The new route on the left skirts a temporary wetland and is bounded by areas cut to promote the development of grassland.

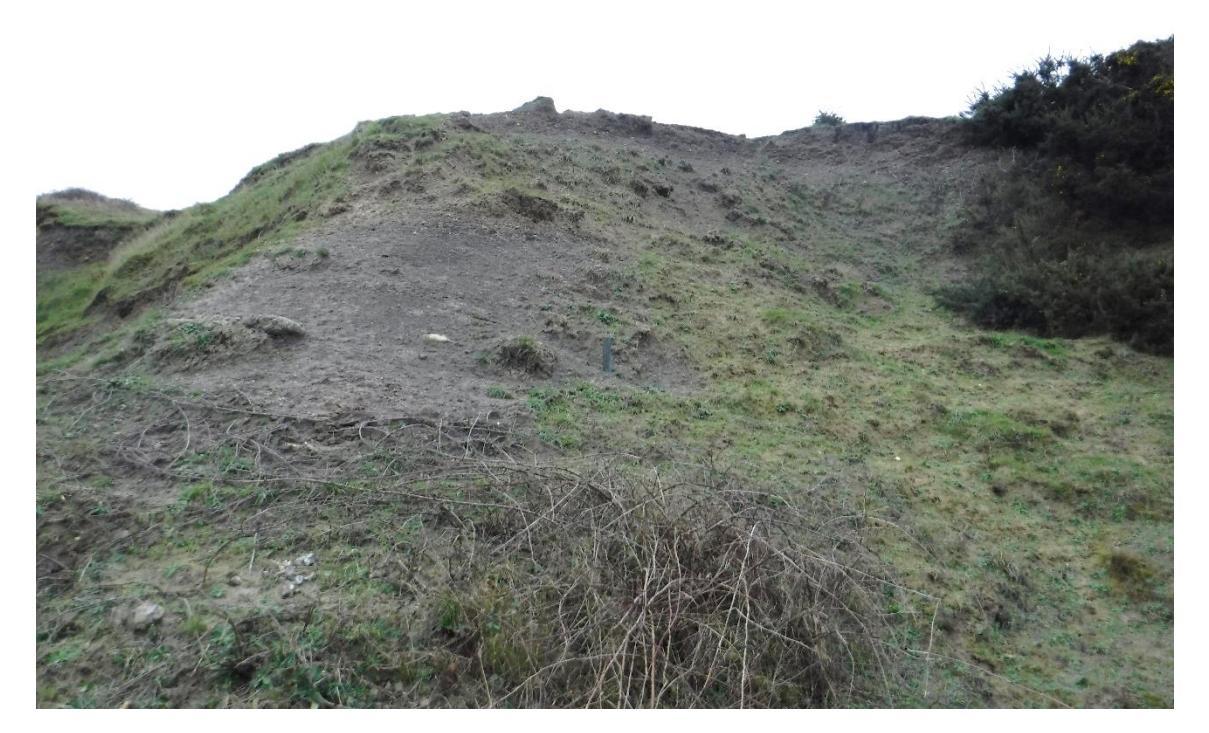
Photo 6 Location C (21 Feb 20). Small-scale recent sliding has revealed a horizon with abundant Gryphaea sp. towards the top of the slope and small light-coloured septarian concretions lower in the slope. From the descriptions in Figure 2 it seems likely that this exposure is in the Athleta Zone of the Stewartby member, and the geological boundary on the site plan (Figure 1) has been amended accordingly. This needs to be verified by more detailed field study. The thick gorse scrub on the right of the photo appears to conceal a potentially unstable backscar.

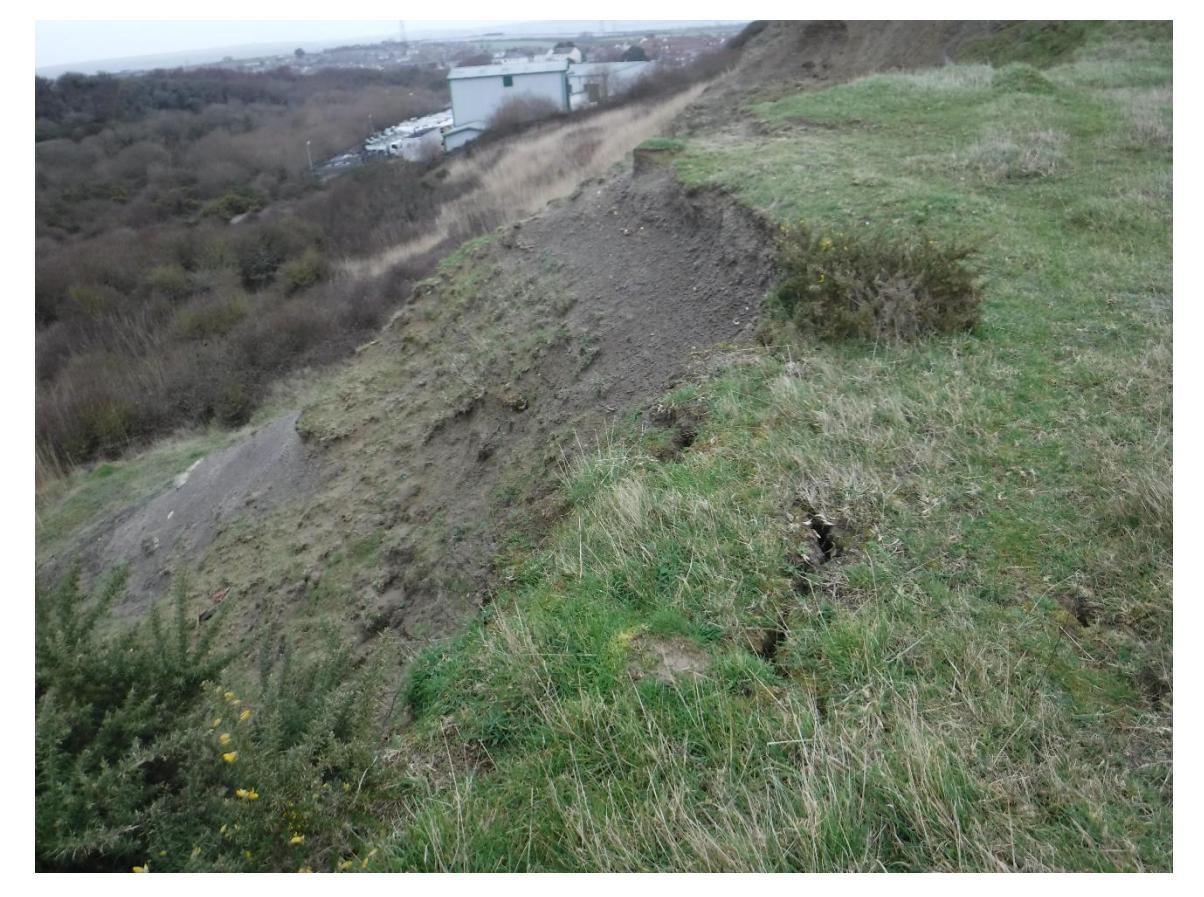
Photo 7 Tension cracks behind the top of the slope at Location C (21 Feb 20). The very small pale rounded objects just below the top of the slope are Gryphaea fossils. Further sliding at this location is likely and therefore any shallow scraping to facilitate access will need to be carried out very carefully.

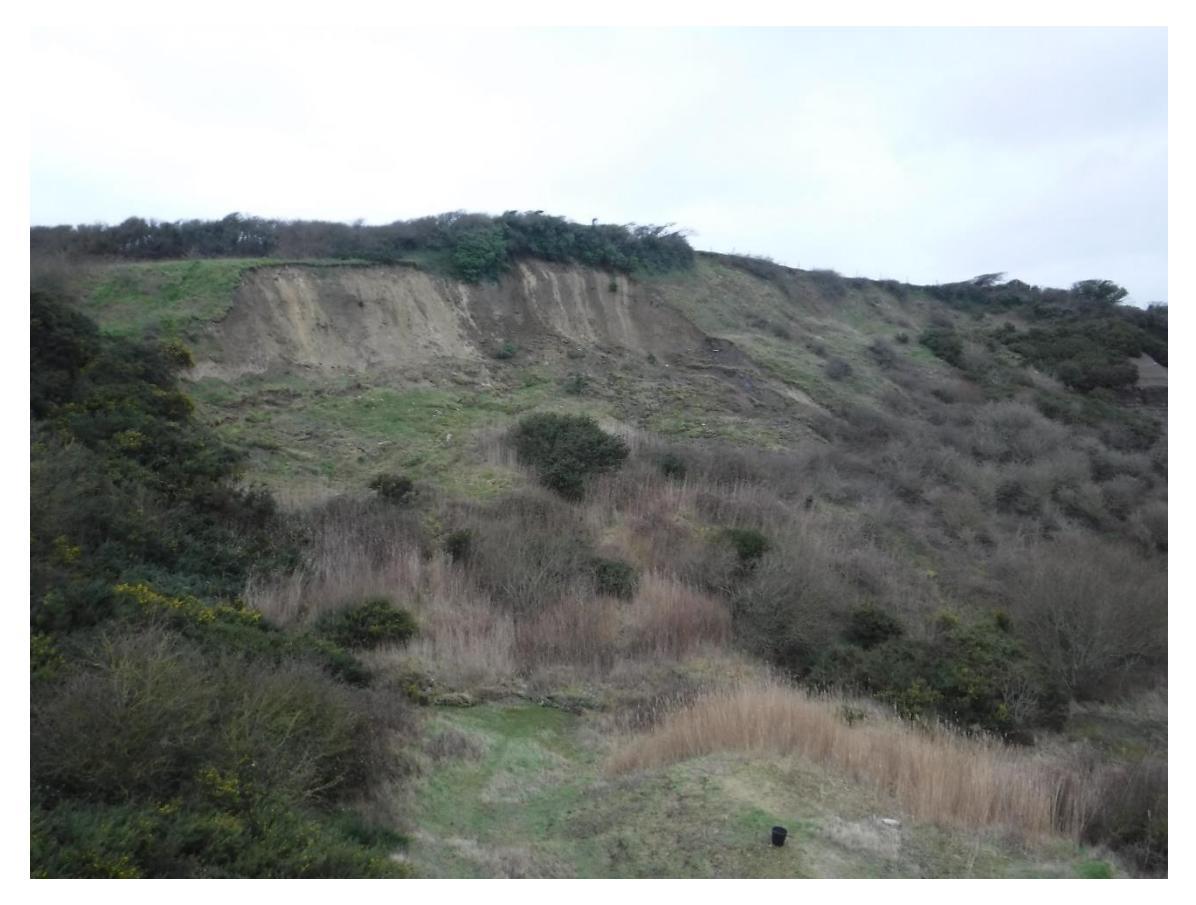
Photo 8 Fresh landslide on the West Face (21 Feb 20). The high backscar in Stewartby Member clays may shortly affect the public footpath above the pit. The toe of the slide extends as far as the green patch of grass in the foreground, where groundwater issues and drains to the wetland in Photo 5. This feature is worthy of academic study and comparison with local coastal slides in the Oxford Clay. The disturbed ground also has high ecological value. The slide removed the original access path to Location B, but this had already been superseded by a more direct route (see Figure 1).

Various types of slope failure are illustrated in Figure 3. The clays would be classed as 'earth' and the shales as very weak 'rock' (although possibly as an overconsolidated clay by a geotechnical engineer). The recent slide on the West Face might be described as a 'composite earth fall and translational slide grading to mud flow at toe', providing an opportunity for further study and robust discussion. Translation may be related to rain infiltration and groundwater movement during the preceding very wet winter. Pore water pressure would have increased, and consequently shear strength decreased, in Stewartby clays along the gently ESE-dipping boundary with the underlying Peterborough shales. Slope height and angle, particle size distribution and clay mineralogy are also important factors that might be considered.

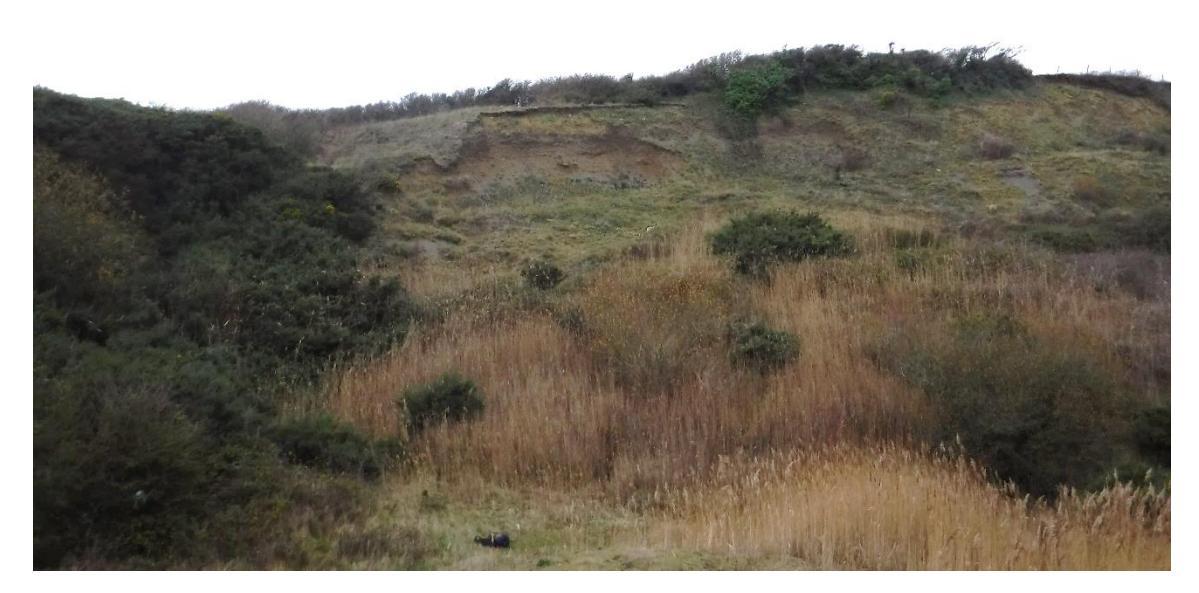
Photo 9 Area of landslide shown in Photo 8 on 11 December 2018. During this earlier visit it seemed likely that the entire slope would gradually degrade to a stable angle rather than fail in the rather dramatic event that occurred during persistent rainfall in January-February 2020.

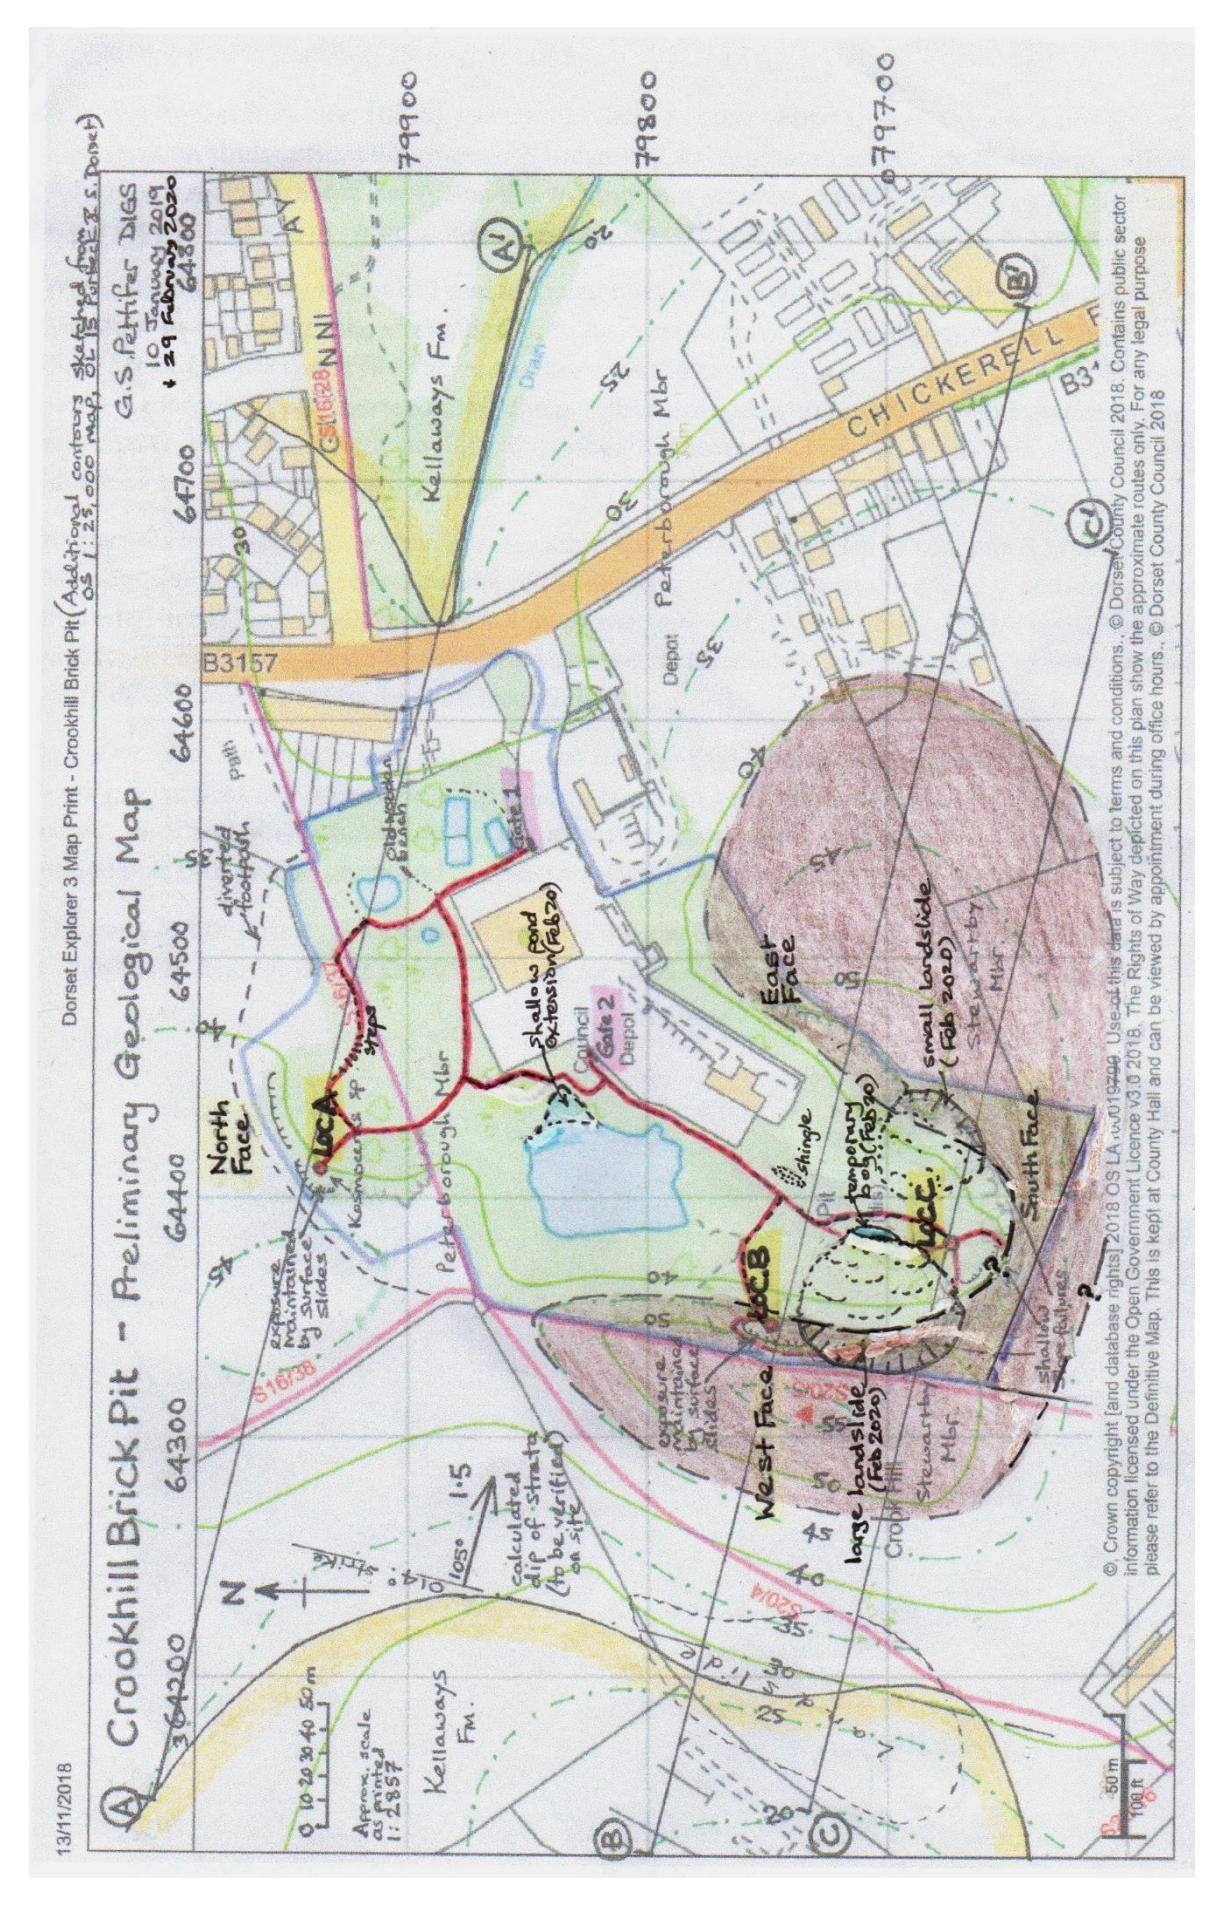
Figure 1Site plan.Updated following visit on 21 February 2020. The approximate positions of paths are shown in red.

Five DIGS members (Roger, Andy, Paul, Geoff R and Geoff P) and Lyn Cooch ((Nature Conservation Officer, Dorset Council) formed the work party. We achieved a great deal, clearing or realigning sections of access paths that were either hazardous or totally obliterated by the recent landslide on the West Face and opening up sites for geological or ecological reasons (see photos 1-9 below). The weather remained dry all day, and we did not encounter great crested newts. An updated site plan is given in Figure 1.

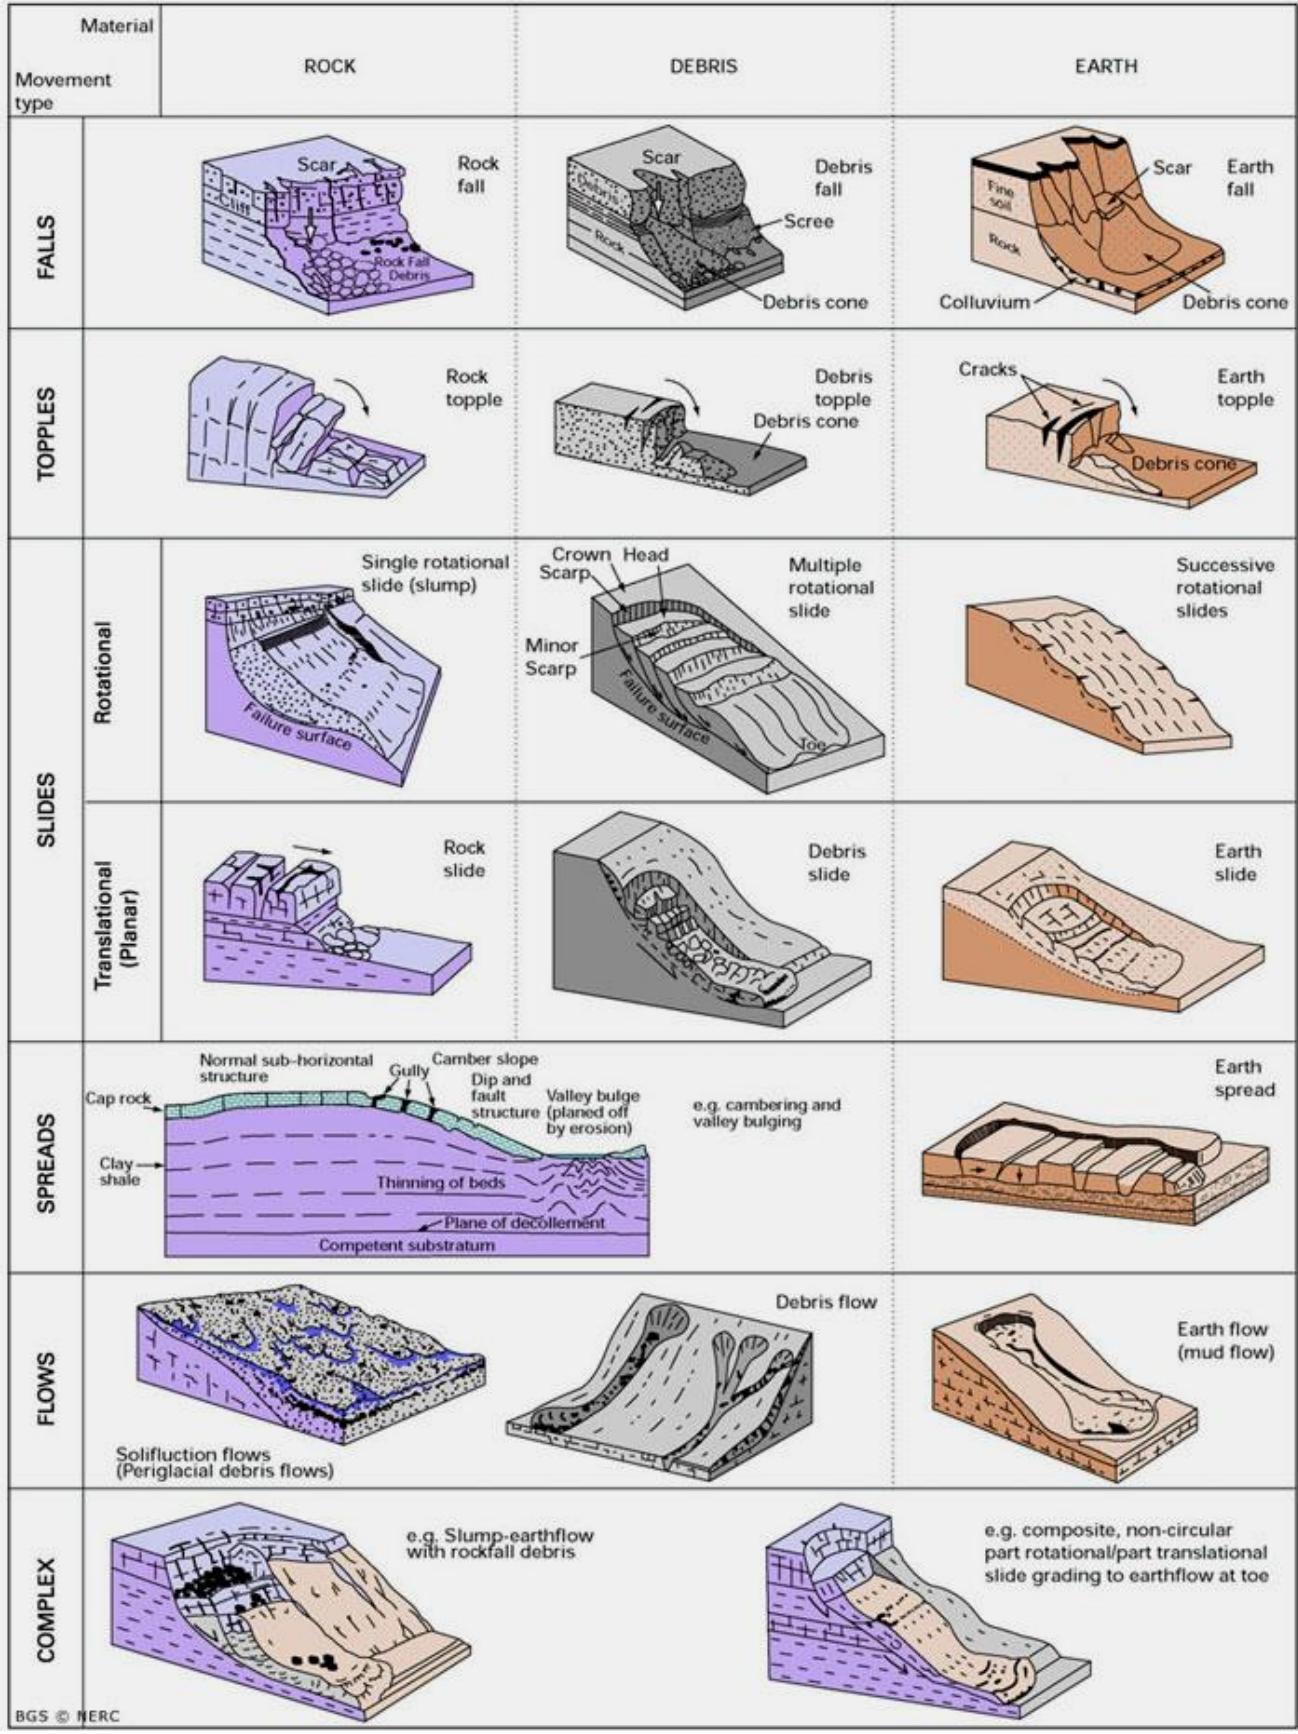
Figure 3 Various types of slope failure identified by the British Geological Survey
